Milwaukee River Basin Report Card **2019**

MONITORING STREAM FLOW AND NUTRIENT LOADS IN THE UPPER MILWAUKEE RIVER WATERSHED

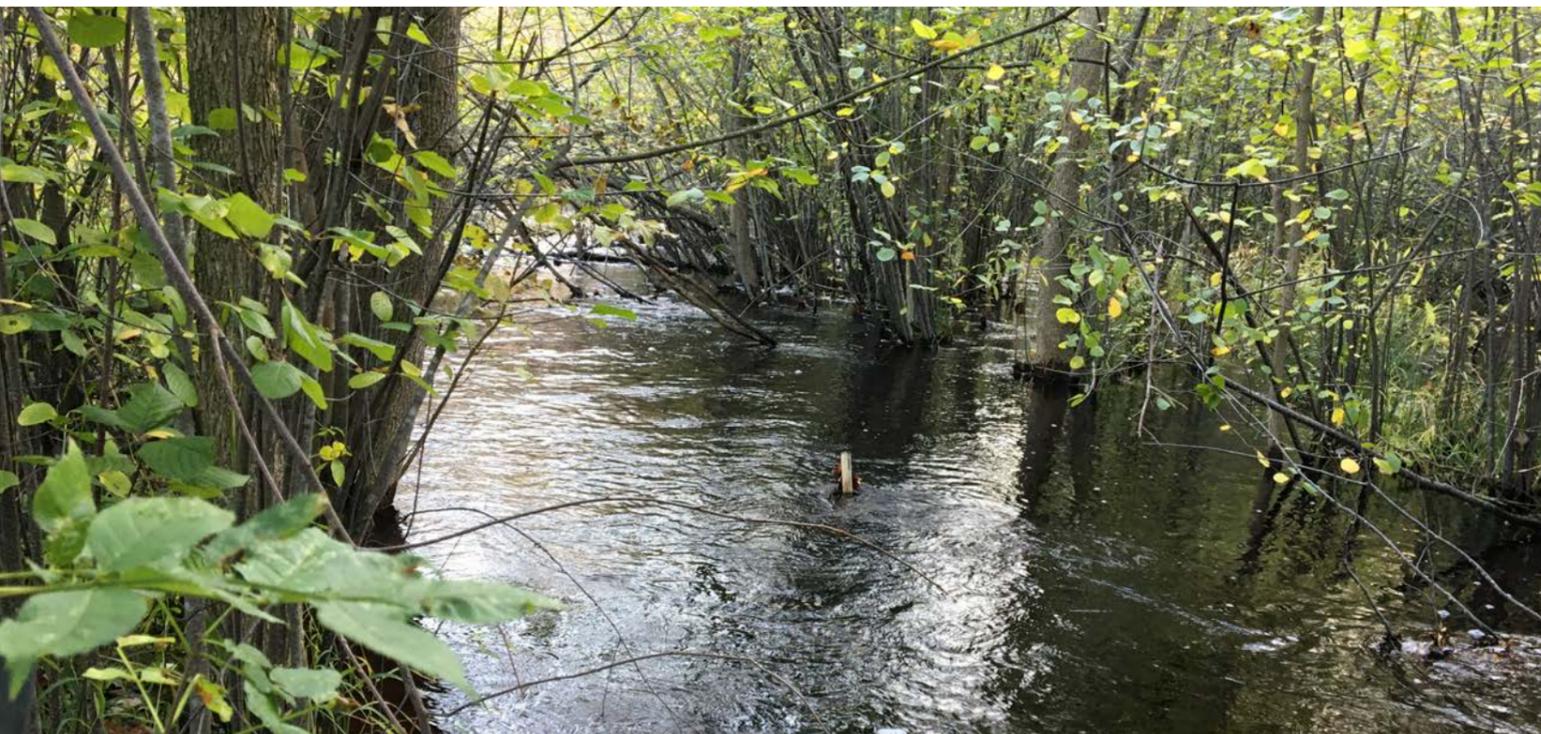
Surface water quality data, continuous stage (water level) and stream flow measurements, the measurement of a volume of water that passes a given location within a period of time (cubic feet per second), were collected at 25 representative sites within the Milwaukee River Watershed (Figure 1). Monitoring locations for this project can be seen throughout this report card identified by the symbol. Monthly water samples were analyzed by MMSD lab staff for TSS, TP, FC and *E. coli*. In stream measurements were taken for dissolved oxygen (DO), pH, water temperature and specific conductance; stage and discharge were measured monthly at the 25 sites during ice-off conditions beginning September 2017 through November 2019. Samples were also collected at four of the 25 sites during seven wet weather events.

Figure 1. Locations (N=25) for collection of water quality data (TSS, TP, FC, *E. coli*, DO, pH, specific conductance, water temperature and turbidity) and continuous stage and discharge measurements in portions of the Milwaukee River Watershed.
